# OLD GOLD?

## FORD SIERRA

**AGEING SIERRAS ARE CHEAP BUT SPECIAL CARE IS NEEDED WHEN BUYING, says Kim Henson.**

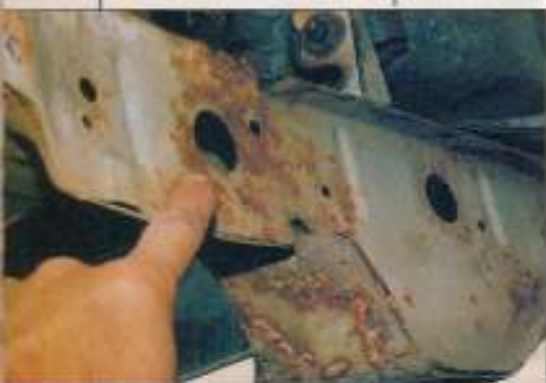
Front crossmember and surrounding structure are usually hidden by engine. However, closely inspect the vitally important steelwork here. If corrosion is widespread look for another car.

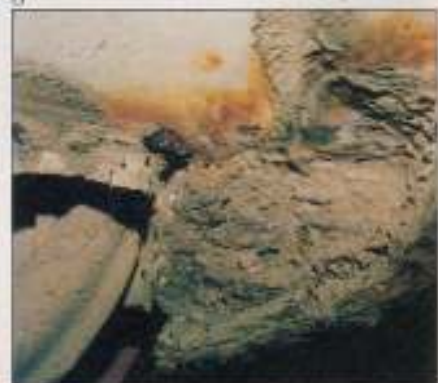
From within each rear wheelarch, look forwards and establish condition of 'splash' panel, sill rear end and structure supporting rear suspension arm. Serious rust here is very bad news.

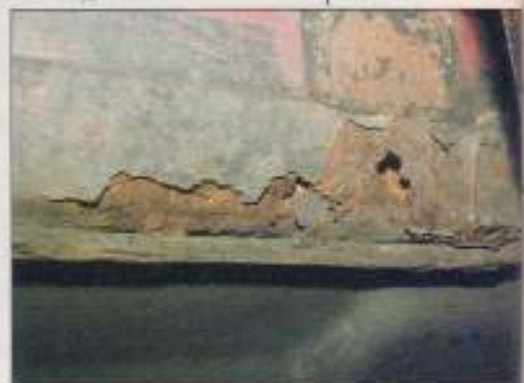
Sills are often weak, and the lower edges are especially vulnerable. If you are looking at a mixture of holes, rusty steel and various patches, bargain on extensive repairs further in!

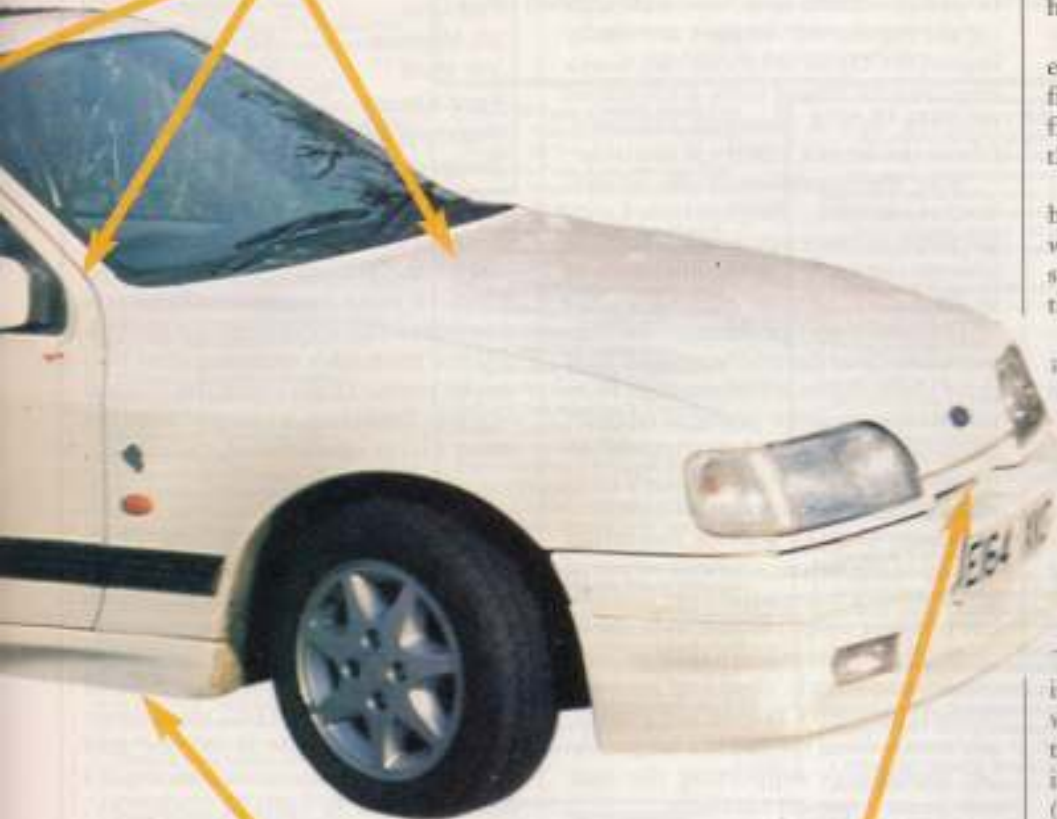
CHECK FOR ROT IN  
SCREEN PILLARS, DOOR PILLARS  
AND BULKHEADS

CHASSIS  
RUNNERS AND SILLS CAN  
HARBOUR RUST

STRUCTURE AT  
FRONT OF CAR MAY  
BE CRUMBLING

Rust can strike virtually anywhere, but particularly in the front and rear extremities of the 'chassis' runners, sill assemblies, front and rear valance panels, front cross-member and adjacent structural beams, suspension mounting points, floor pans, screen pillars and bulkhead/door pillar assemblies. If rust is found in the rear 'chassis', the fuel tank will have to come out for repairs. Inspect the rear structure from within the boot and from under the vehicle.

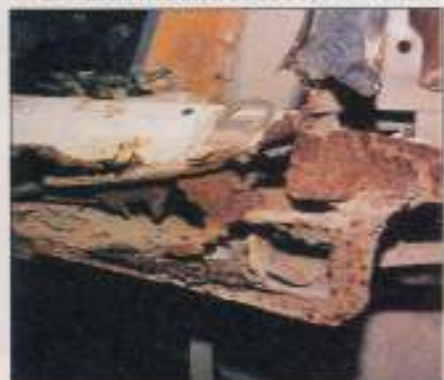
Lower rear valance panel is rust-prone on all models (this estate was in a very poor condition). Such damage is not usually confined to one area of the vehicle; check thoroughly - everywhere!

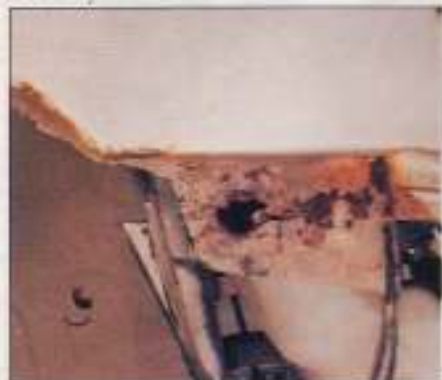
Front and rear wheelarch lips, and the wing sections normally masked by the upper edges of the bumpers, are often holed/wafer-thin. Check by eye and feel. Examine inner wheelarches too.

edges (view from outside and underneath). Both front and rear wings can disintegrate too – particularly around the arches, also the sections normally hidden by the bumpers.

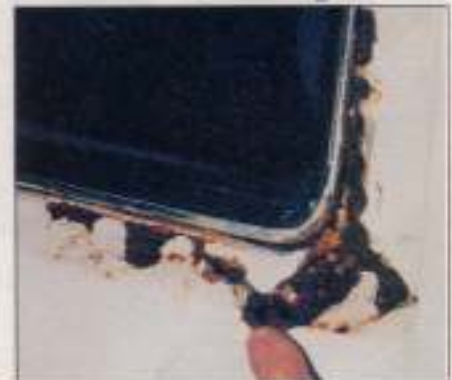
Doors can be very rusty, even on cars only a few years old. Start by inspecting the sloping 'edges' immediately below the windows. Look for glass fibre and body filler, as well as 'honest' rust!

Outer body panels aren't immune either. The doors are especially vulnerable; check under and around the window frames, and along the lower

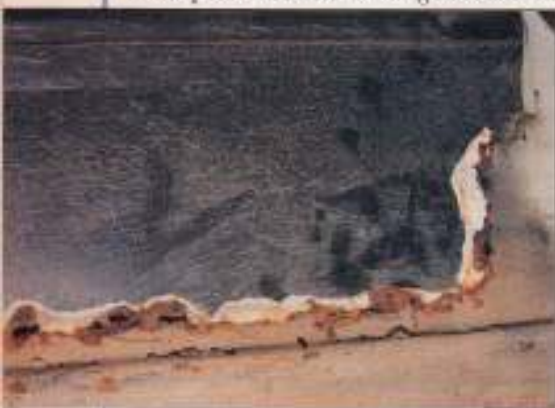
Lower edges of doors (and tailgate/bootlid) may be virtually non-existent. Usually the most cost-effective solution is to find a secondhand panel in better condition if the rest of the car is sound.

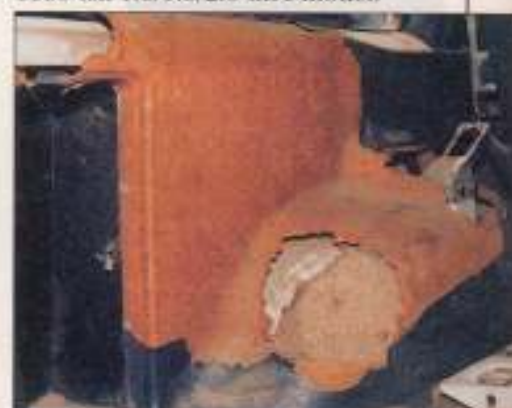
The luggage compartment can tell you a great deal about the car's use and how well (or otherwise) it has been looked after. This estate appears to have been half-eaten by a hungry dog!

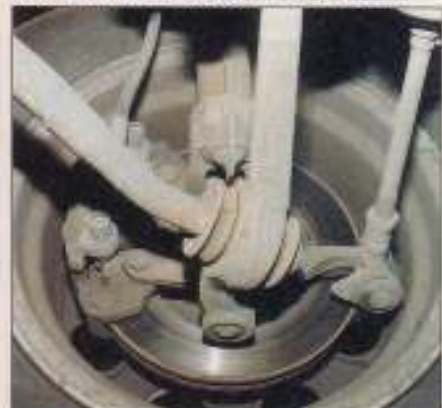
Front suspension and steering require close scrutiny, especially the multitude of rubber bushes, brake discs (they often wear rapidly), and the steering rack (watch for torn gaiters).

Ensure that all rubber mounting bushes in the suspension system are in good condition (especially the anti-roll bar to lower suspension arm bushes), or the car will drive 'like a sponge' (you can feel the vehicle 'shunting' on worn bushes) and MoT failure will eventually result. Vital too are the large rubber mountings supporting the rear sub-frame – inspect carefully.

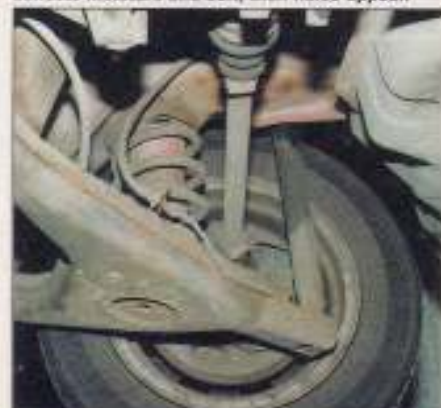
At the rear, check out the driveshaft gaiters, mounting bushes for the rear sub-frame/trailing arms, and condition of the steel suspension components. Deficiencies here spell MoT failure.

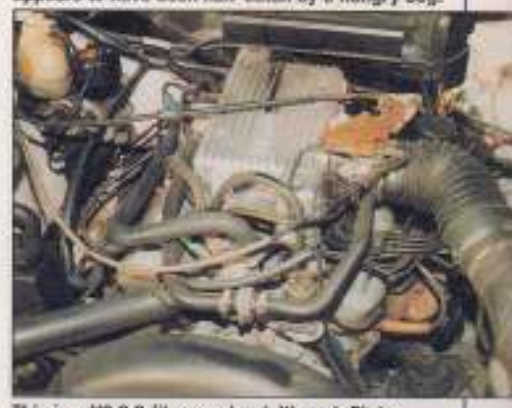
This is a V6 2.8-litre version (although Pinto powered Sierras predominate). Check for oil leaks, 'top end' noise and timing gear rattle. On Pinto units, watch for oil leaks and smoking, and listen for clattering from worn camshaft/followers.

The 2.3 and 2.8-litre V6 'Cologne' engines are pretty reliable, but again infrequent oil/filter changes result in

premature valve gear wear (pushrods and tappets) and 'top end noise'. The timing gears can also wear/rattle.
